Manhole Inspection Summary

Manhole # S19A__009MH

Location Address: **740 LANVALE ST**

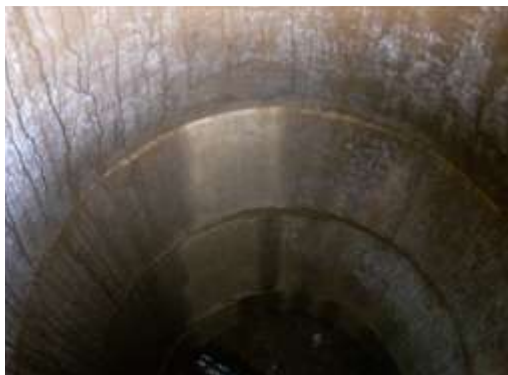
Defect 5

Infiltration: ☐ None ☒ **Joint** ☐ Cracks ☐ Mortar ☐ Roots ☐ Wall

Infiltration: ☐ None ☐ Joint ☐ Cracks ☐ Mortar ☐ Roots ☒ **Wall**

INFILTRATION OF CORBEL JOINT AND BARREL WALL

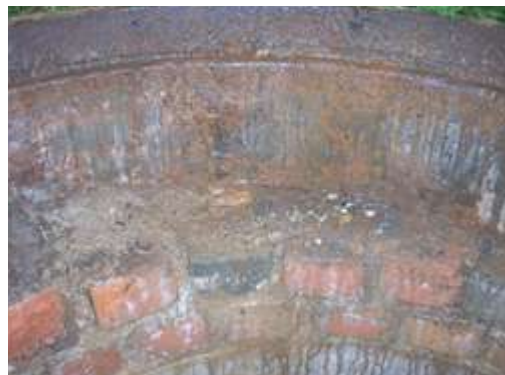
Defect 4

Infiltration: ☐ None ☒ **Joint** ☐ Cracks ☐ Mortar ☐ Roots ☐ Wall

INFILTRATION OF CHIMNEY JOINT

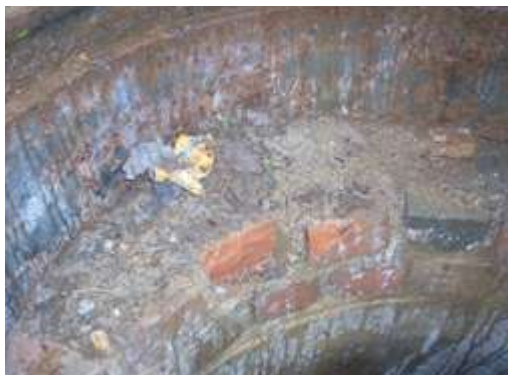
Defect 3

Condition: ☐ Sound ☐ Cracked ☐ Root Intrusion ☐ Loose Brick ☒ **Deteriorated**

DETERIORATED CHIMNEY

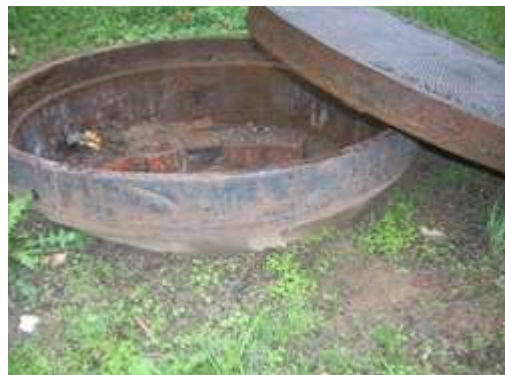
Defect 2

Cover Shape: **Circular** Diameter: **30** (in.) Length: (in.) Dist A/B Grade: **4** (in.)

GRADE ADJUSTMENT

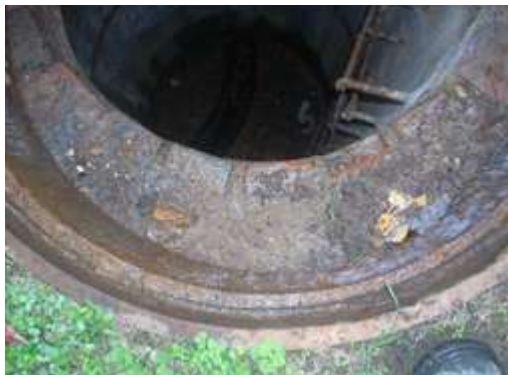
Defect 1

Frame Offset: **5** (in.) Condition: ☒ Sound ☐ Cracked ☐ Leaks

FRAME OFFSET

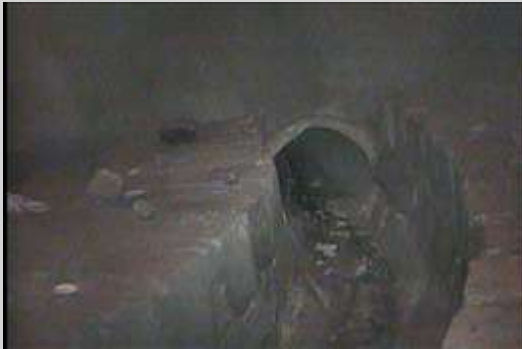
12 O'Clock Outflow

Pipe Height: **8.4** (in.) Rod and Bar (Angled)
Pipe Material: **Clay** ☐ Pipe Lined
Invert Depth: **12.04** (ft.) Flow Characteristics: **Slow**
Deposits: ☐ None ☐ Mud ☐ Sludge ☒ **Debris** ☐ Grease
Silt Depth: **1** (in.) Deposits Extent: **Light**
Infiltration: **None** Pipe Seal Cond: **Sound**
